Service Bulletin # 090
Page 1 of 1
June 9, 2009

Modified Hydro Vent Cap

Subject: New vented hydro caps have a tendency to leak oil on uneven terrain.

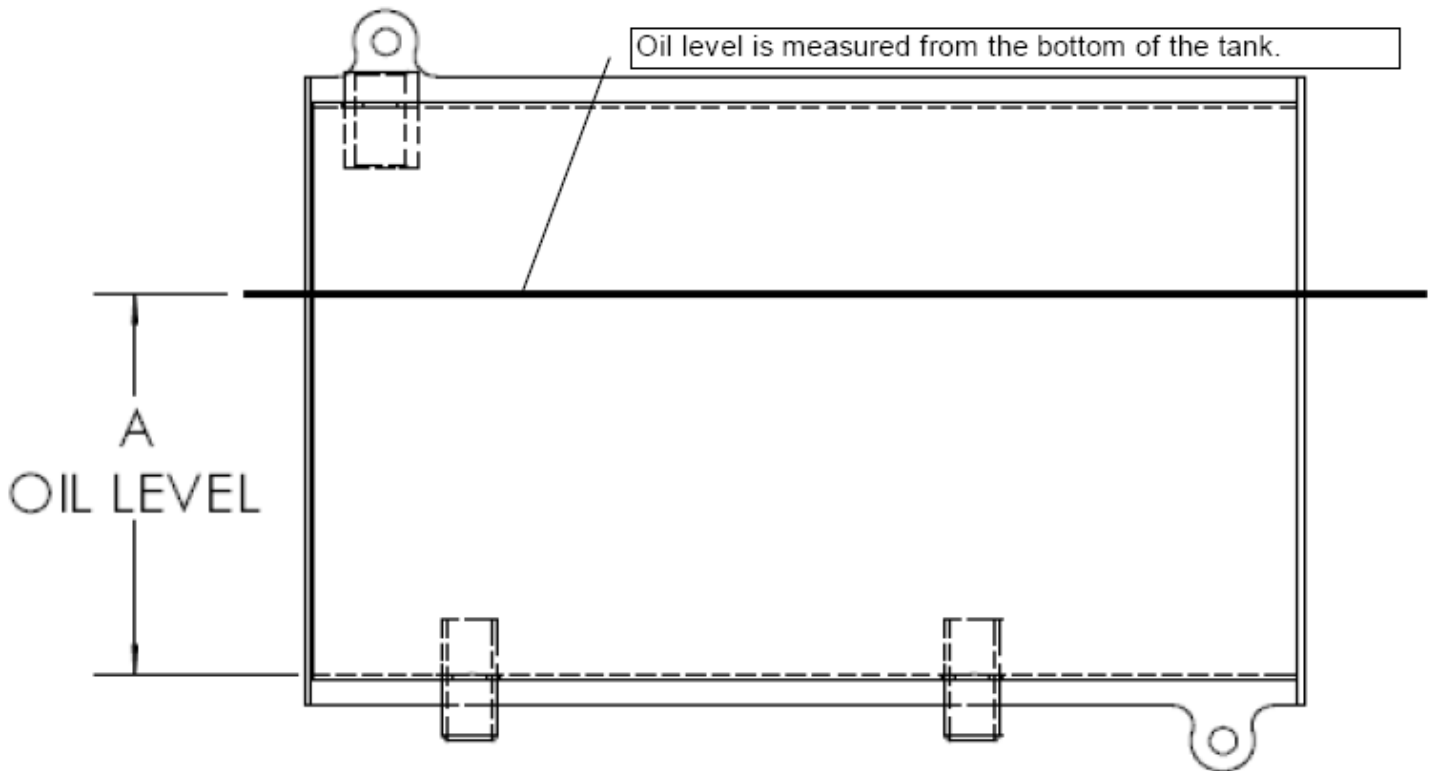
Oil Fill Levels For Wright Mower Hydraulic Systems (Do Not Over Fill)

Situation: Oil leaks from new vented cap. A tube has been added to assist in keeping fluid from passing through the cap. Hydro tank fill levels have also been updated. Keeping the oil at a proper level will assist in keeping oil from leaking. (See Fill Level Chart)

The Fix: It will be at the Distributor/Dealer discretion whether to use the modified vent cap or replace the entire tank. (Ref Service Bulletin 092) ***In rare instances, the modified vent cap leaks on flat terrain.*** Ask your customer questions about the terrains they mow. Ensure hydro tank fluid level is correct. If it is determined a replacement hydro tank is needed, see Service Bulletin 092 for part numbers and details.
