Service Bulletin # 097  
Page 1 of 1  
June 24, 2010

## 71410014 Clutch Wire Tie Location

**Subject:** Revised wire tie procedure for the 71410014 clutch

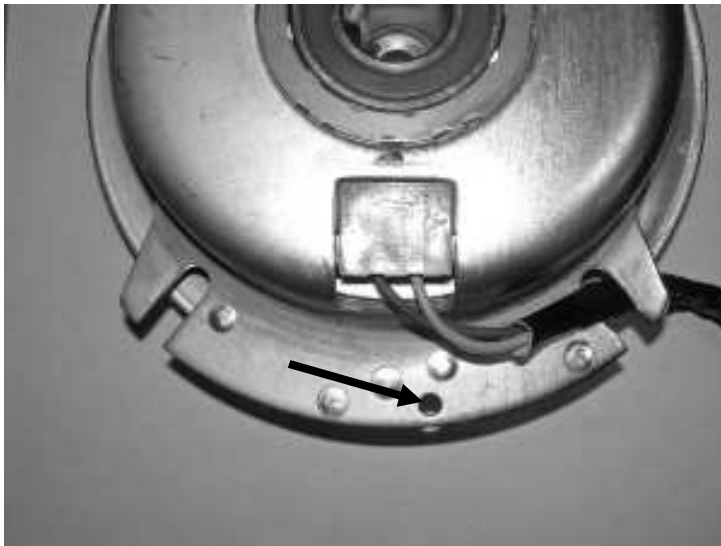
**Situation:** Possibility for the clutch wires to break when the clutch wire was only wire tied to the clutch stop.

Location for Wire Tie

**The Fix:** Using an existing hole in the clutch bell housing the clutch wire will be wire tied to the hole to keep the wire stationary at the clutch during the operation of the clutch.

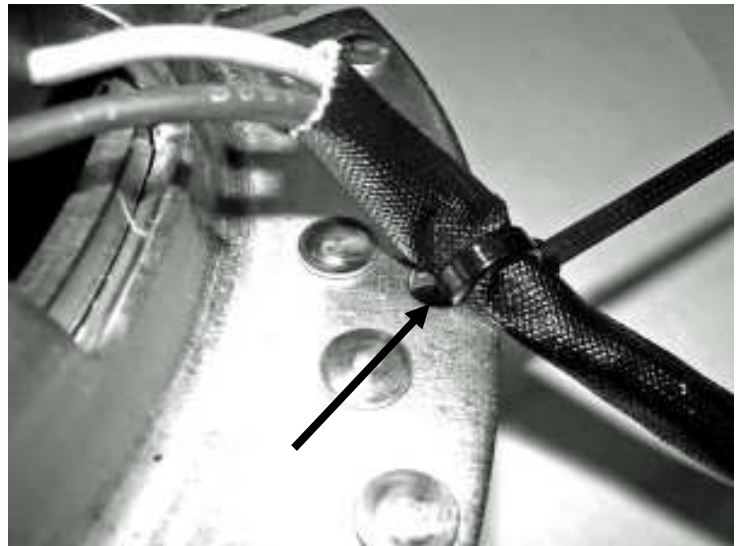
Wire tie prior to installing
