Service Bulletin # 096
Page 1 of 2
June 24, 2010

High Pressure Hose Routing

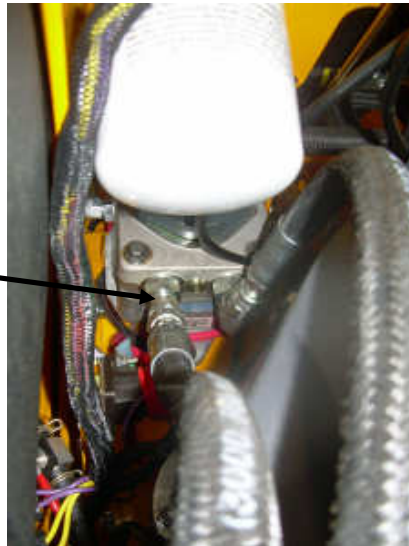
35410046
45 degree fitting

- Subject:** High pressure hoses rubbing on hydraulic filter and engine shrouds
- Units Affected:** All Sentar Sports and Stander RH
- Situation:** On the above models, the hoses have been wearing through the hydro filter and engine shrouds. The hoses will need to be re-routed in order to eliminate the rubbing.
- The Fix:** Add a 45 degree fitting on right port of right hydro pump and using bow tie style zip ties on hoses. Instructions are attached to this bulletin.
- Claim Procedure:** 1.5 hours allowed if work performed within the normal warranty period of the mower.

- 1) Inspect all HP hoses and hydro filter for wear. Replace hoses if worn to steel lining. Replace filter if showing signs of wear. Refer to your IPL for parts numbers.
- 2) If hoses do not need to be replaced, remove fitting on right port of right pump and install a 45 degree fitting P/N 35410046.
